Evaluations, Repairs, and Retrofits of the Historic Sherman Building in Washington, DC Following the 2011 Mineral, VA Earthquake.

Craig D. Swift, PE, SE, LEED AP¹, Matthew J. Daw, PE, LEEP AP², and Laura M. Burgess, EIT, MEng³

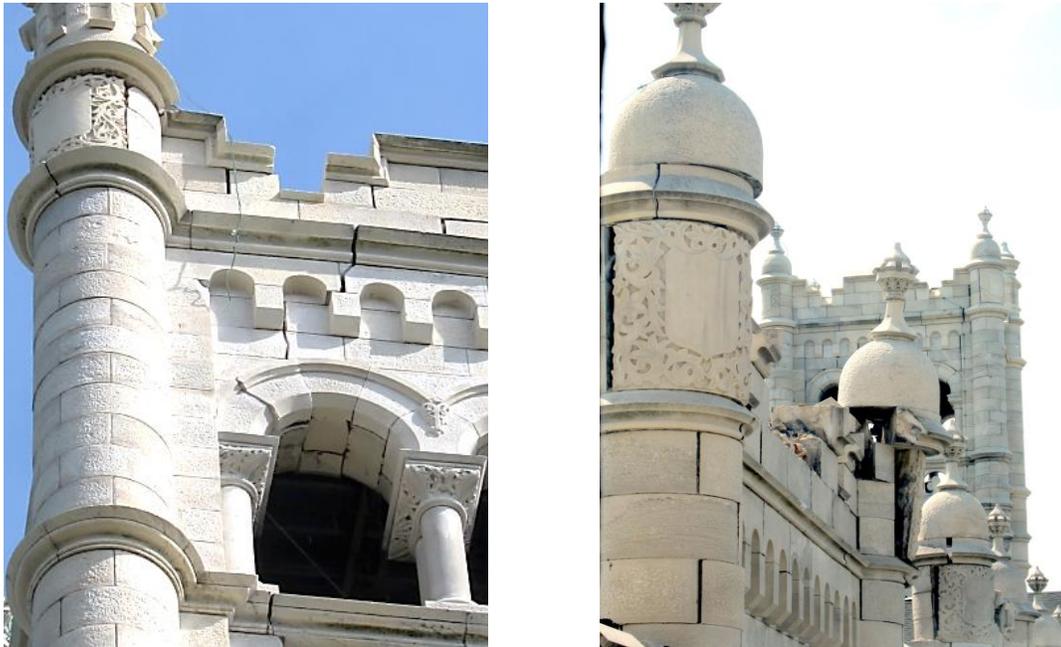
At the start of the project in July 2012, the full extent of damage to the Sherman Building was not fully known. Visible conditions included hundreds of fallen and removed stones, gaping holes in the roof, collapsed retaining walls, and destroyed interior finishes. The substantial cracking and displacement of masonry were the major known structural damage concerns, see Figures 1 & 2. However, the extent of structural damage remained largely unknown.

Figures 1 & 2. Displaced masonry. (Preservescapes 2011 with permission from Preservescapes)

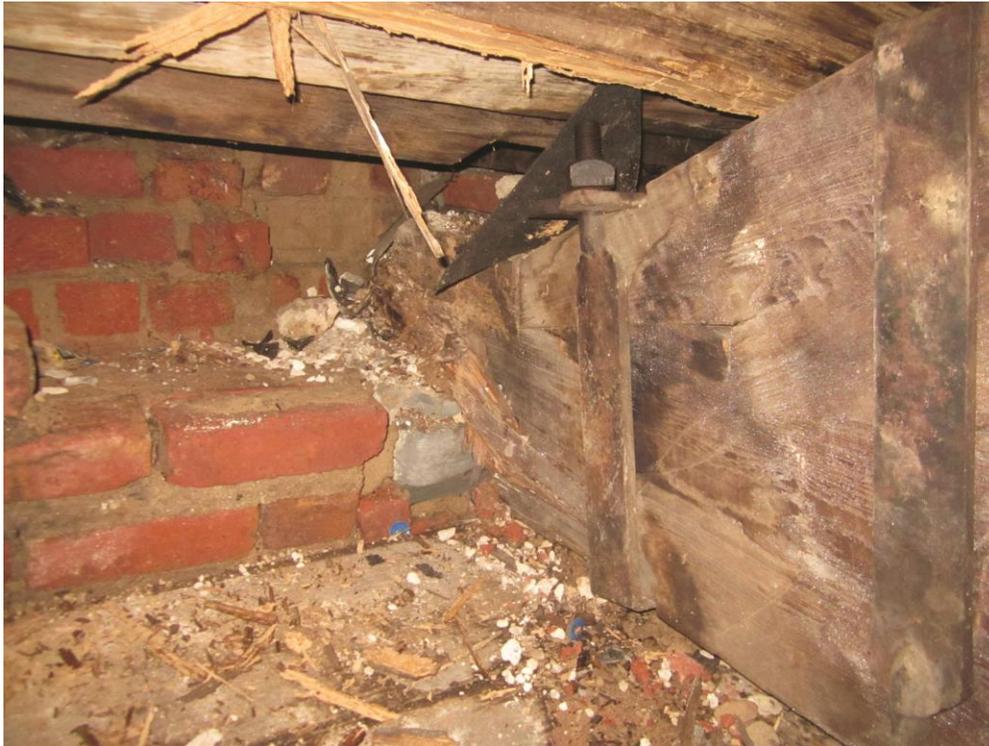
In the attic of the structure, existing wooden roof truss distress was visually apparent, with damage related to both the earthquake and years of moisture decay and termite infestation, see Figure 3. Heel joints at the exterior walls, already weakened by earlier deterioration, subsequently failed during the earthquake and caused wall separation. The existing timber trusses required an in-depth review using non-destructive resistance drill testing. Additional building components affected by the earthquake included the building chimneys. The chimneys collapsed during the seismic activity and required new structural elements to replace the fragile and flexible masonry structure.

Figure 3. Deterioration in roof truss. (Keast & Hood 2013, with permission from Keast & Hood)

Taking cues from the firm's past historic intervention approaches, notably Philadelphia's Academy of Music, Keast & Hood engineers designed steel reinforcements that were carefully threaded into the attic to reestablish the truss heel-joint connections with the wooden trusses. The design necessitated a detailed survey by the fabricator and meticulous installation. Carpenters worked in tandem with the fabricator to install each new piece of steel by hand. Roof truss reinforcement is pictured in Figure 10.

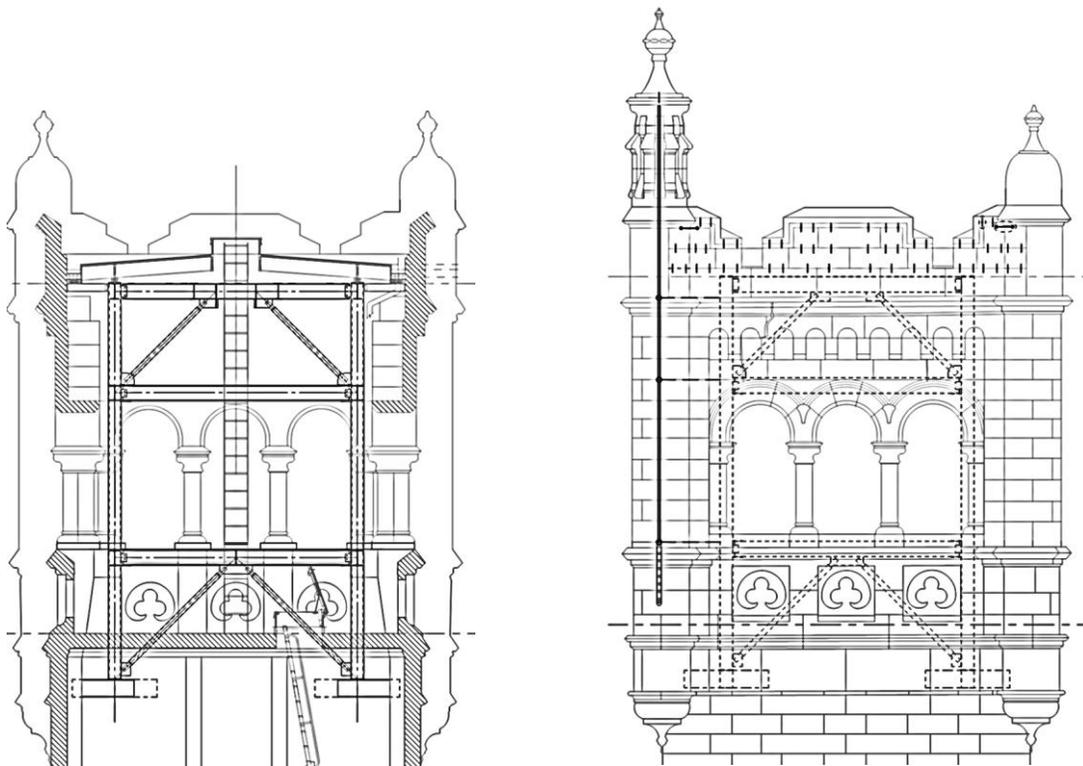
Elaborately and beautifully constructed out of mostly single-wythe stone masonry, the original clock tower's was a key comment of the project seismic retrofit and restoration. While the stone weathered well, the stone performed very poorly in the earthquake.

Figure 4. Steel braced frame. (Keast & Hood 2013, with permission from Keast & Hood)

On the project critical path, a steel braced frame was selected to reinforce and add stiffness to the exposed bell level of the tower without adding significant weight and triggering further reinforcing or foundation upgrades below, see Figures 4 and 5. Although engineers investigated alternative reinforcement options for the towers, including shotcrete, cast-in-place concrete, and reinforced masonry, steel was chosen because it offered more flexibility for design and construction. This decision was also logical in terms of safety, scheduling, and aesthetic standpoints. Steel could be fabricated off-site and installed quickly, benefitting the project's fast-track schedule. Additionally, the steel frame's lightweight nature posed further benefits by avoiding the cost and time of reinforcing the existing foundation design. The effort represents the delicate balance of structural reinforcement and historic preservation required by the project.

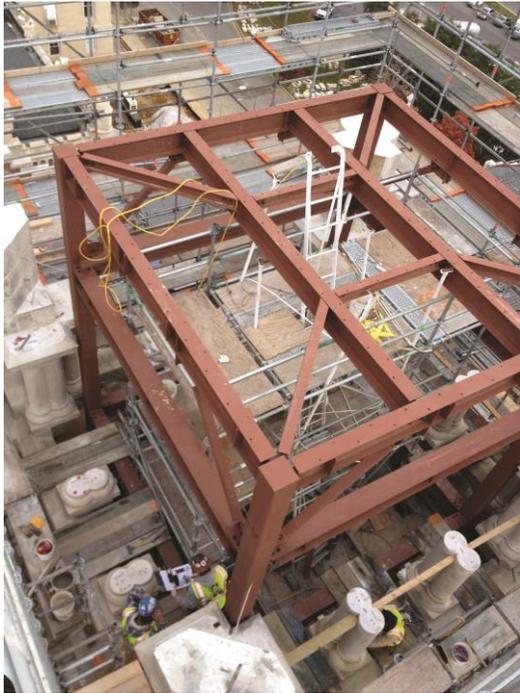
Figure 5. Steel braced frame.

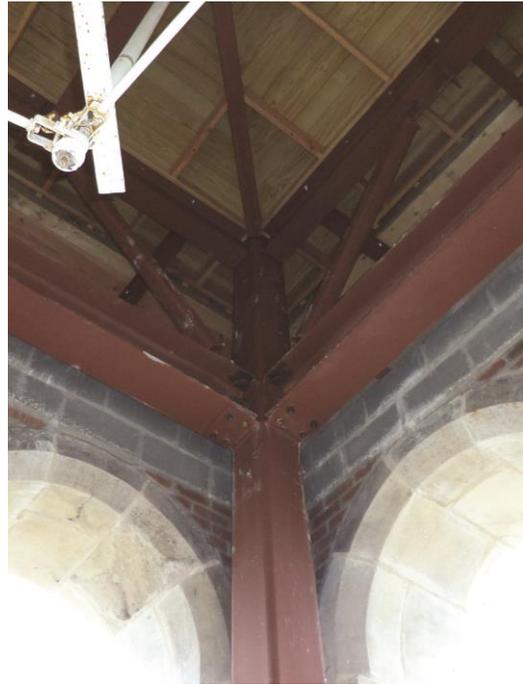
Figure 6. Steel frame from interior.

The steel came in the form of roughly 40 pieces, most of them in the 10-to-15-ft range: W14x48, W12x53, and W6x16. The 26-ft-tall columns were made of HSS10x10x½. Angle pieces were used to create new frames for masonry support.

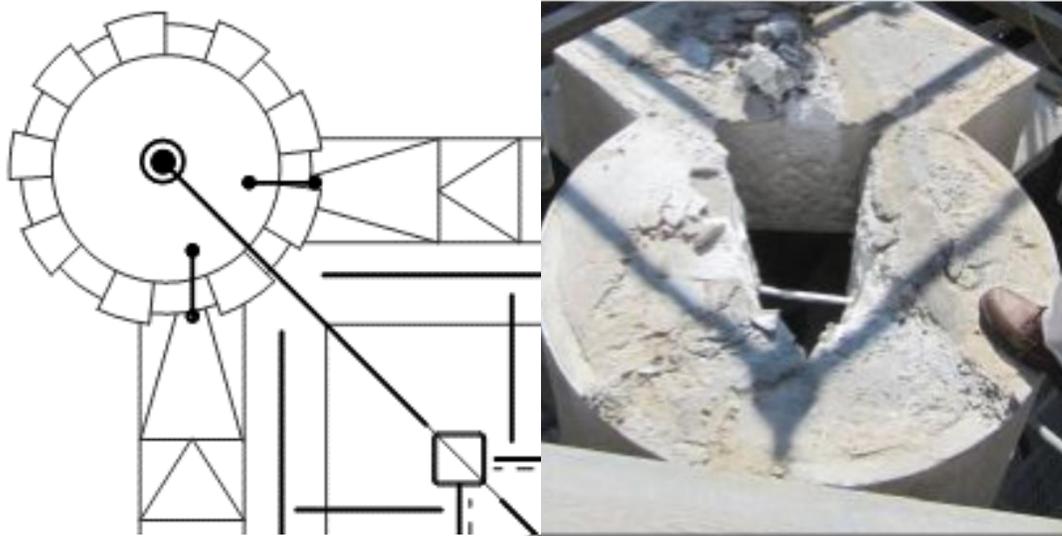
Figure 7. Masonry restraint. (Keast & Hood 2013, with permission from Keast & Hood)

Large protruding corner turrets were repaired with a grouted sock anchor approach. Stainless steel threaded rods within fabric socks were inserted into dry core-drilled holes in the masonry and filled with cementitious grout for proper bond and compatibility with the historic fabric, see Figure 7. This solution stabilized the fragile masonry while providing permanent reinforcement for the turrets and tower. It is interesting to note no two courses were identical in stone geometry. Furthermore, the geometry of each cornerstone was unique in that no cornerstone was identical. Repairs accommodated the large variance in stone geometry.

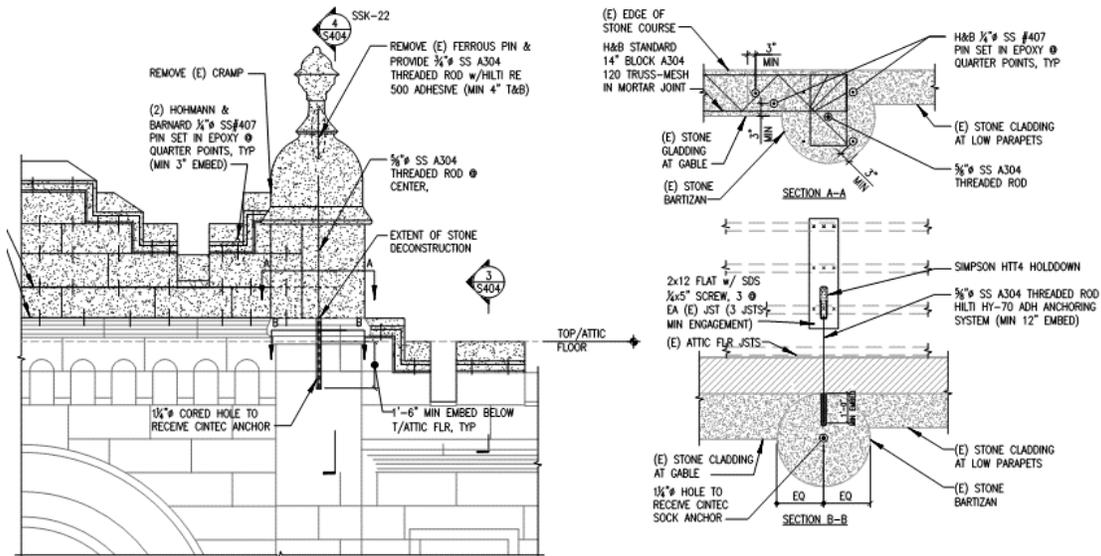
Figure 8. Masonry Anchorage. (Keast & Hood 2013, with permission from Keast & Hood)

Additional exterior masonry elements were repaired by similar means of grouted sock anchors with steel tie backs to the structural masonry backup (brick), see Figure 8.

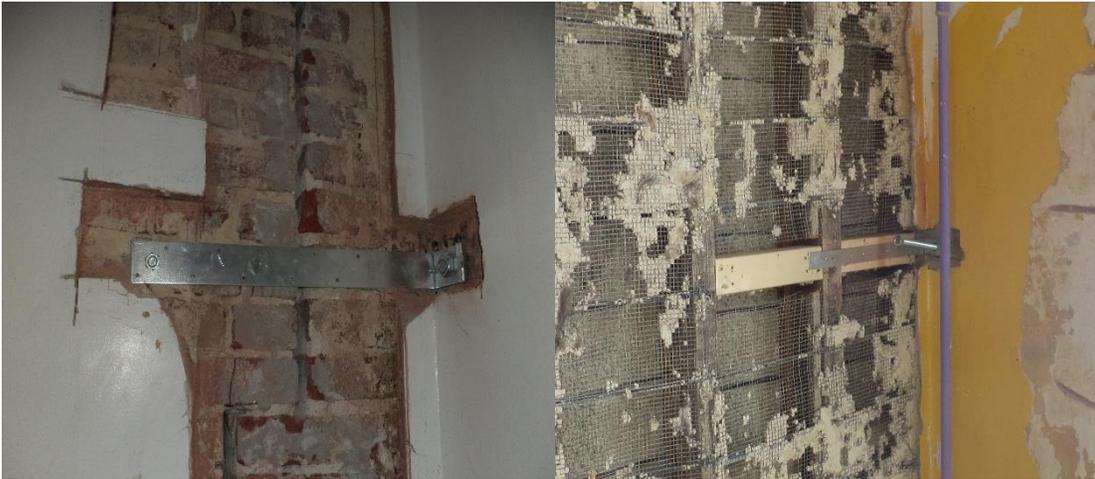
Figure 9. Exterior / Interior Wall Anchorage. (Keast & Hood 2013, with permission from Keast & Hood)

Beyond masonry reconstruction and embedded reinforcement, engineers provided positive mechanical anchorage of the exterior masonry walls to the wood framed floors and bonded the dress stone to the structural masonry backup with concealed helical anchors and cold-formed plates where new steel strap anchors were introduced at the floor levels and exterior / interior wall intersections, see Figure 9. Positive anchorage was also provided at the original cast iron portico using concealed stainless steel fasteners.

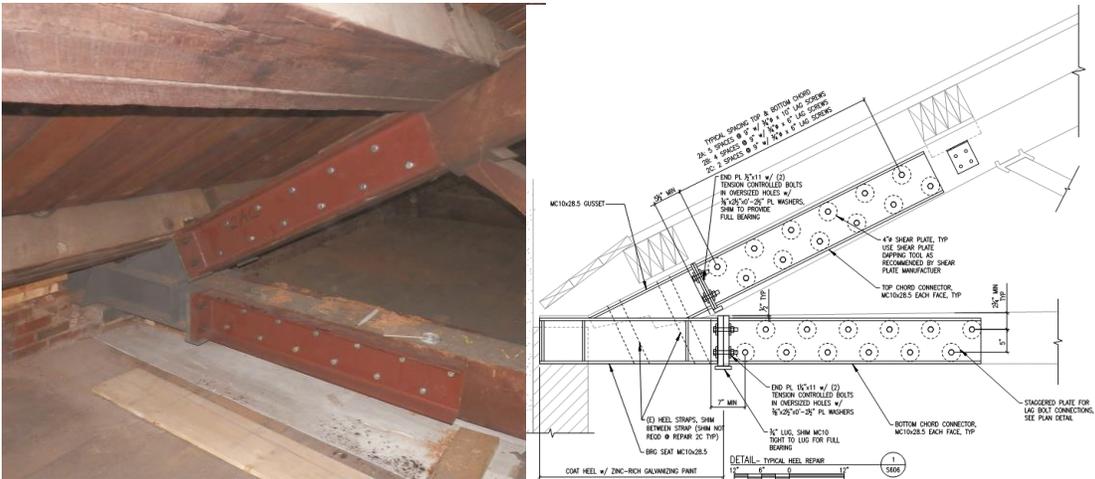
Figure 10. Roof truss reinforcement and bearing. (Keast & Hood 2013, with permission from Keast & Hood)

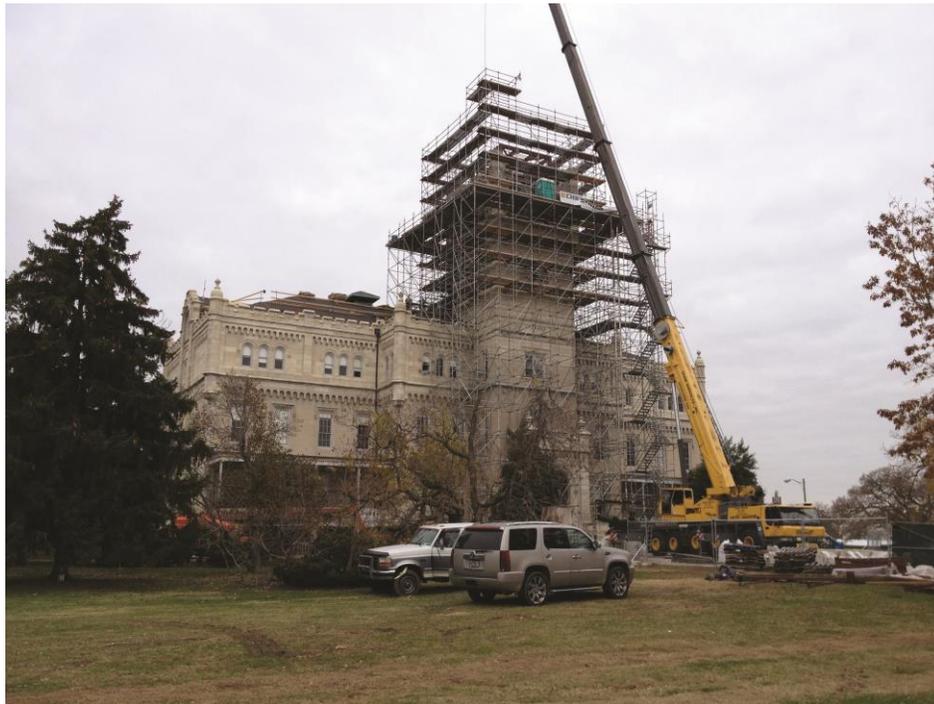
In response to the extent and severity of the observed distresses, partial deconstruction of the tower was required. Over 20 courses (rows of bricks) of the masonry tower were dismantled and rebuilt around a new structural steel eccentric braced frame (EBF) assembly in conjunction with selective internal reinforcements, see Figure 11. Existing conditions such as rounded stone edges, tapering brick backup and the varying cuts and sizes of the original stone impacted the design.

Figure 11. Disassembly of clock tower. (Keast & Hood 2013, with permission from Keast & Hood)

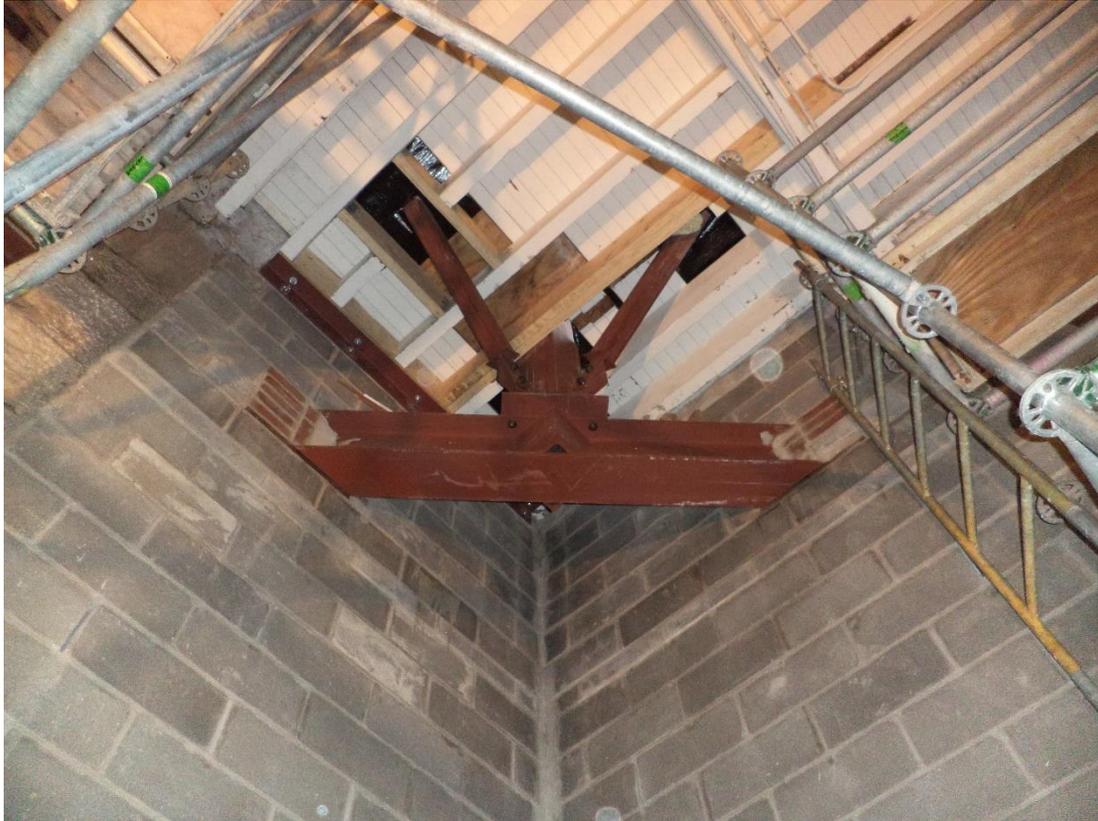
Figure 12. Internal Masonry Shear Wall for Steel Frame. (Keast & Hood 2013, with permission from Keast & Hood)

Steel erection only took a few days, and installation required scaffolding the entire tower and deconstructing the tower to a working level just below the existing clock tower deck. New steel was installed using a self-erecting tower crane. A new CMU shear wall was built to

support the base of the internal steel frame, see Figure 12. A scaffold system was then erected in the third floor office to the underside of the clock level. Due to the tight confines of the existing spiral stair, which was blocked by the scaffolding, a small opening was cut in the clock level floor to haul block pallets and other construction materials up into the tower.

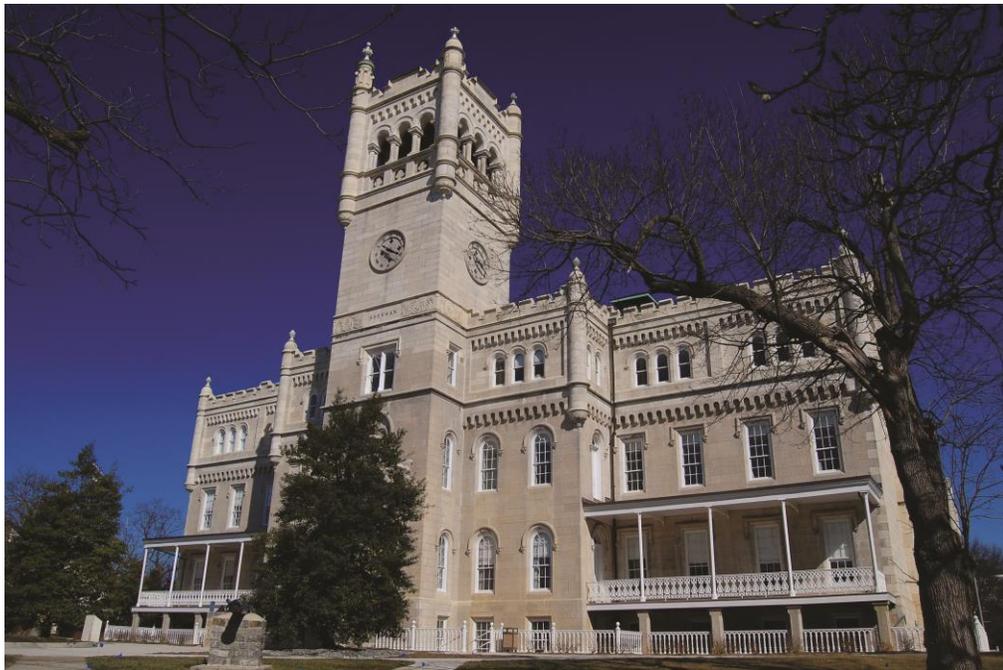
Figure 13. Restored and reinforced Sherman Building. (Keast & Hood 2013, with permission from Keast & Hood)

Structural steel tower reinforcement, masonry restoration, cast-iron railing repairs, timber truss strengthening and other structural restoration efforts were made to bring the Sherman Building back from devastation, see Figure 13. More than 3,000 stones in retaining walls, chimneys and parapets were salvaged, catalogued and rebuilt using nearly 100% of the original hand-carved marble. The \$14 million project not only restored the building but also reinstated the home and sense of national pride for 500-plus military veterans who reside in the Armed Forces Retirement Home and the Sherman Building.
